Monitoraggio della temperatura nelle strutture arginali per il riconoscimento dei flussi idraulici

*(Temperature monitoring in the levees for detection
of seepage)*

Ing. Fabio De Polo
Agenzia per la Protezione Civile
Provincia Autonoma Bolzano

Aim of project

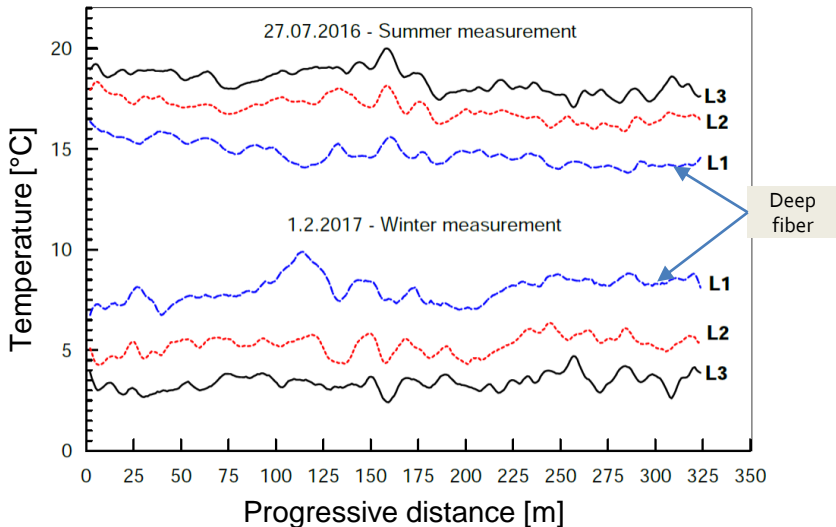
1° test site in Salerno

Temperature profiles in summer and winter

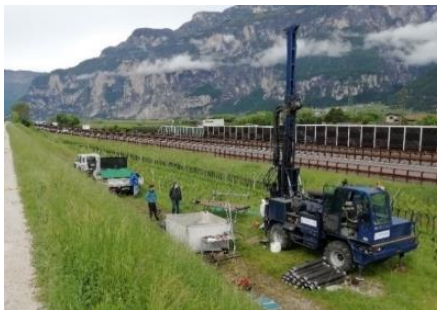
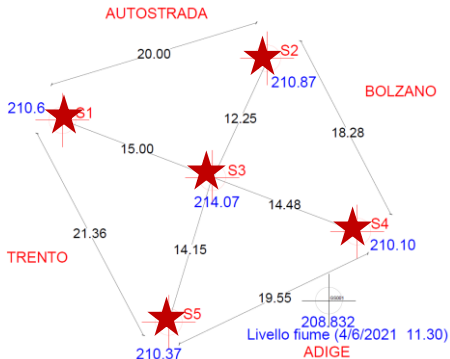
Investigations: geognostic surveys

- 5 surveys at the corners and center (corresponding to the axis of the embankment) of a square 20x20m².
The depth of the surveys is about 25m for the corner ones and 30m for the central so as to reach about the same altitude.

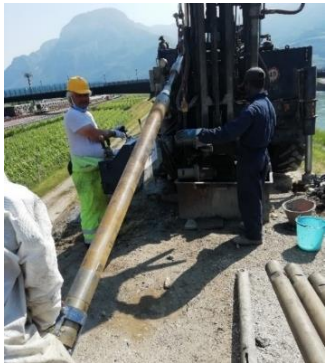
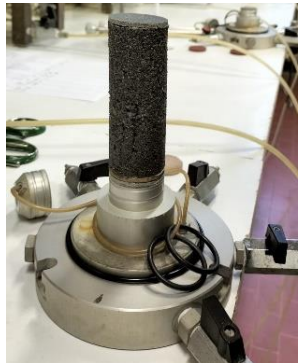
TRIPLE TUBE SAMPLER

- 11 undisturbed taken by Gel-Push Sampling in S₃ + 10 undisturbed standard + 16 remoulded in S₁, S₂, S₄ e S₅.
3. Laboratory tests of classification, permeability and compressibility in Tx

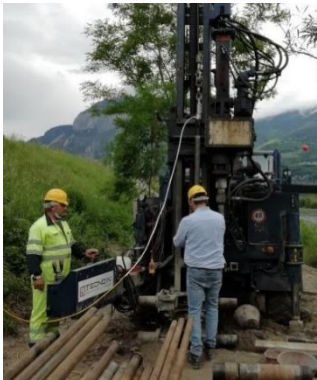
Investigations: in-situ permeability tests

4. SPT and Lefranc tests in coarse-grained soils
5. On-site permeability tests with a BAT type permeameter, specifically made for coarse-grained soils (sandy sands and gravels).

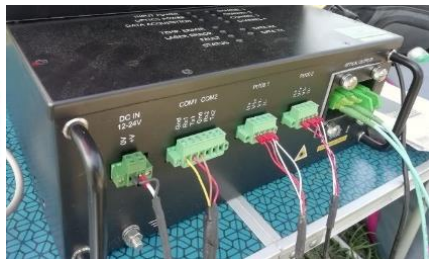
New monitoring system: DFOS

1. BRUsens® AHFO DTS with 2 multimode fibers to measure the temperature change along the depth.

Fiber exploited with Raman mode with Oryx SR DTS of Sensornet (spatial resolution = 2m, accuracy = 0.1°C).

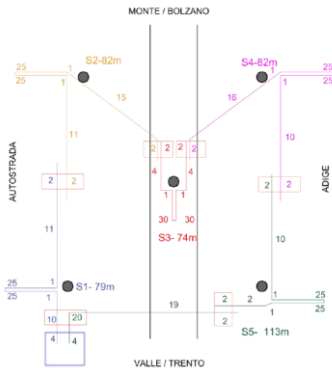
New monitoring system: DFOS

Preparation of pieces of fiber, subsequently joined, to allow the removal of the coating of the coating of the sample

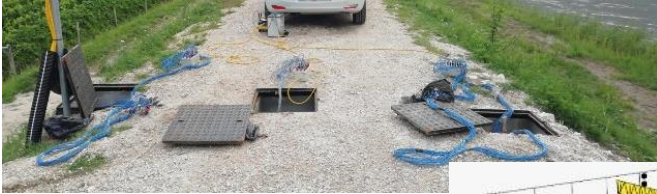
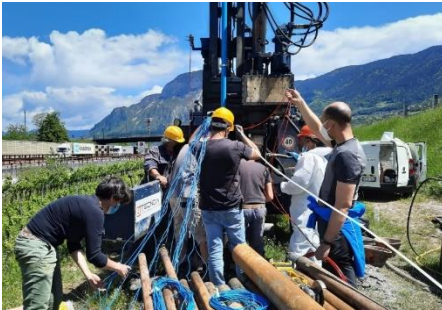
New monitoring system: ERT

2. Cables for 3D ERT surveys of soils under the embankment, exploiting the sensors of three holes at a time;

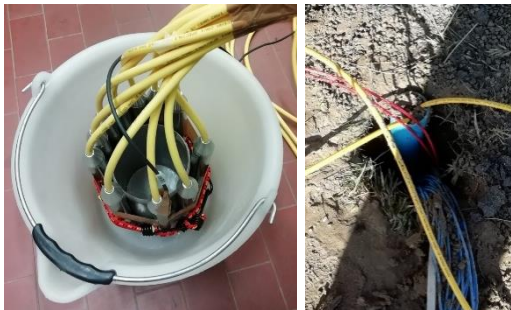
Monitoring system: traditional sensors

3. Piezo/thermometric probes (2 per hole) with hourly measure. Accuracy: 2cm column H₂O and 0.1°C.

Laboratory calibration of thermometric probes

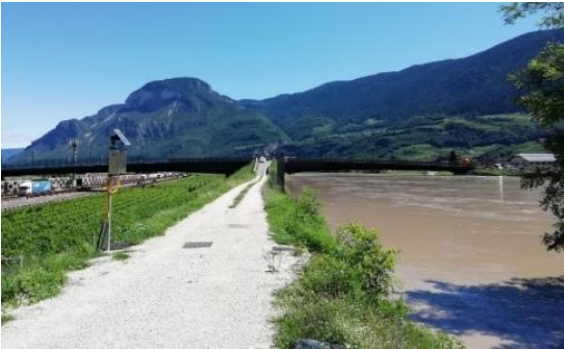
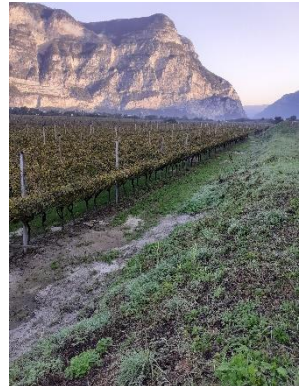
Monitoring results

The hydrometric level in the river rose by 4.2 m in 11 hours, reaching an altitude of 213.4 m above sea level (70 cm above sea level) at 11.00 am on 5/8/2021.

Numerous fountains were visible at the foot of the embankment on the countryside side.

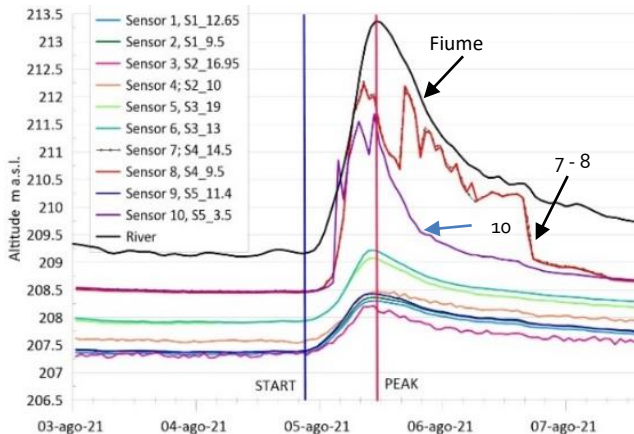
Monitoring results

The most reactive sensors are the 7, 8 and 10, but the response of the 7 and 8 is anomalous because it is much faster than the others (1-2 hours against the 4-5 hours of the others).

On the countryside side the variation is much smaller: only 1-1.2 m.

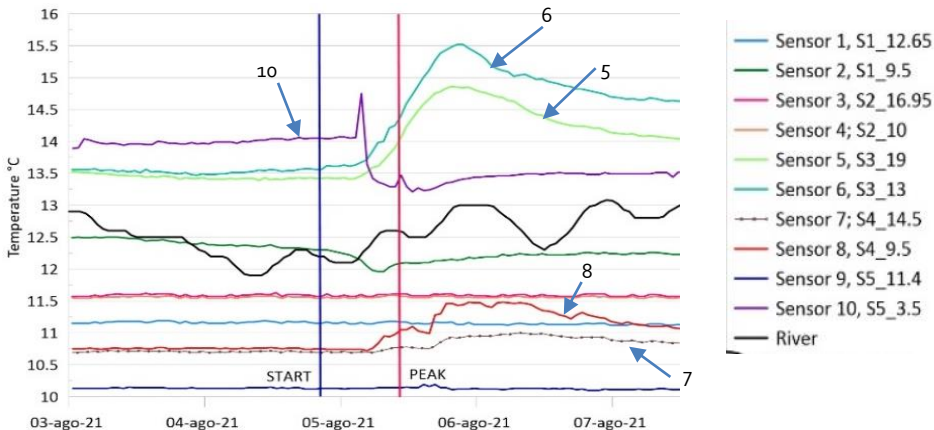
Monitoring results

The water temperature in the river drops by about 1°C . Only sensor 10, the closest to the bottom of the river, records a drop of about 0.7°C .

Sensors 5, 6, 7 and 8, on the other hand, record an increase of about $0.5\text{--}2^{\circ}\text{C}$ with a certain delay compared to the passage of the flood wave, probably due to the migration of warm waters already resident in the deep layers.

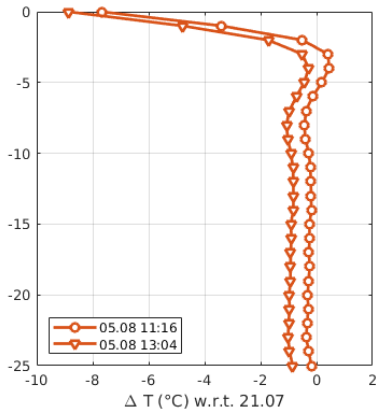
Monitoring results

Nei pozzi lungo il fiume si registra una diminuzione ΔT di 8÷9°C nei primi 2-3 m, forse a causa della sommersione delle teste pozzo che sono solo 2 m sopra il livello di morbida.

Absolute temperature

Temperature change

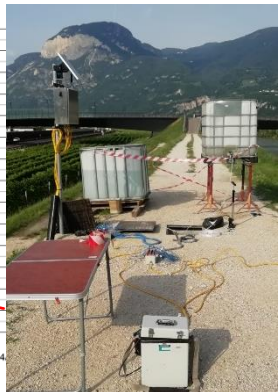
Injection test

Dual packer system used in input tests

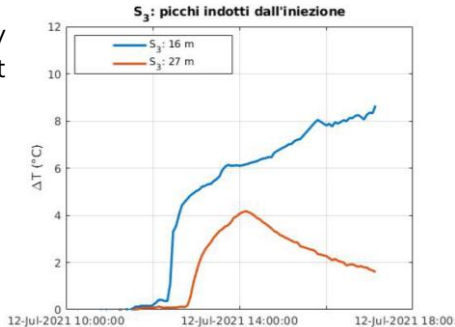
ΔT in S_3 on the 1st day of testing (12 July 2021), calculated with respect to the test start temperature

Evolution of the temperature variation at the two points of greatest variation during injection into the S_3 well.
