**SISTEMI INNOVATIVI DI MONITORAGGIO GEOTECNICO
MEDIANTE SENSORI IN FIBRA OTTICA**

DEFORMAZIONI TERMICHE DI DIGHE IN CALCESTRUZZO

Ponte Cola dam

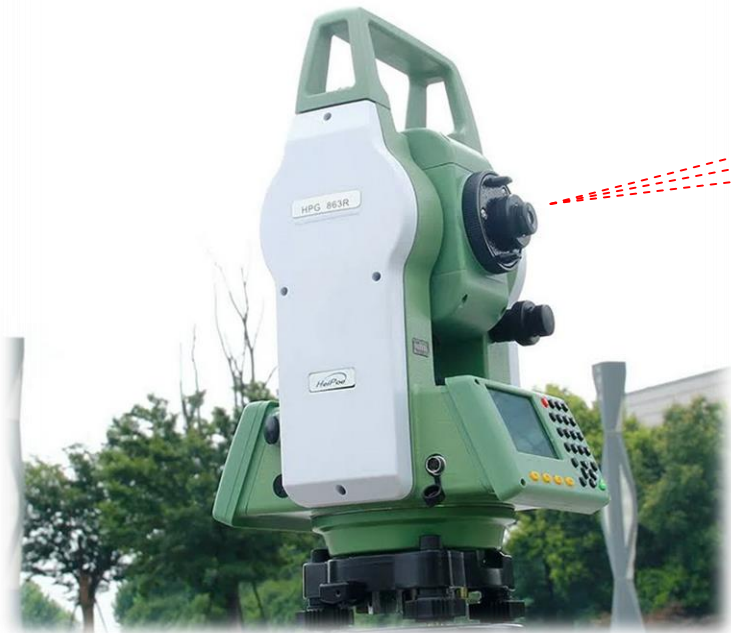
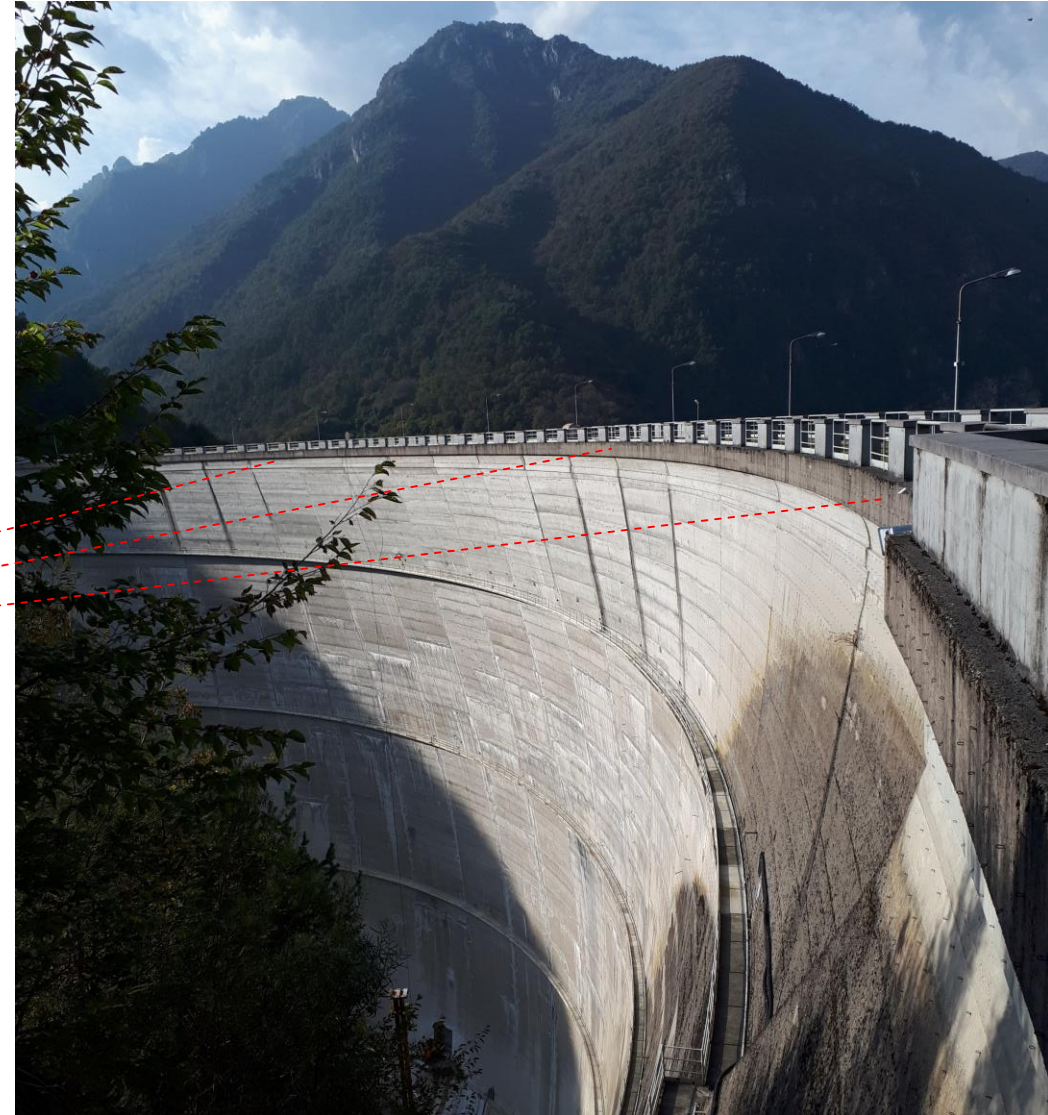
Traditional monitoring system: displacements

Topographic targets on the valley face of the dam:

- **7 targets on the crest at 505 m a.s.l.**
- 4 targets at 490 m a.s.l.
- 4 targets at 465 m a.s.l.
- 3 targets at 440 m a.s.l.
- 1 target on the pump at 412.5 m a.s.l.

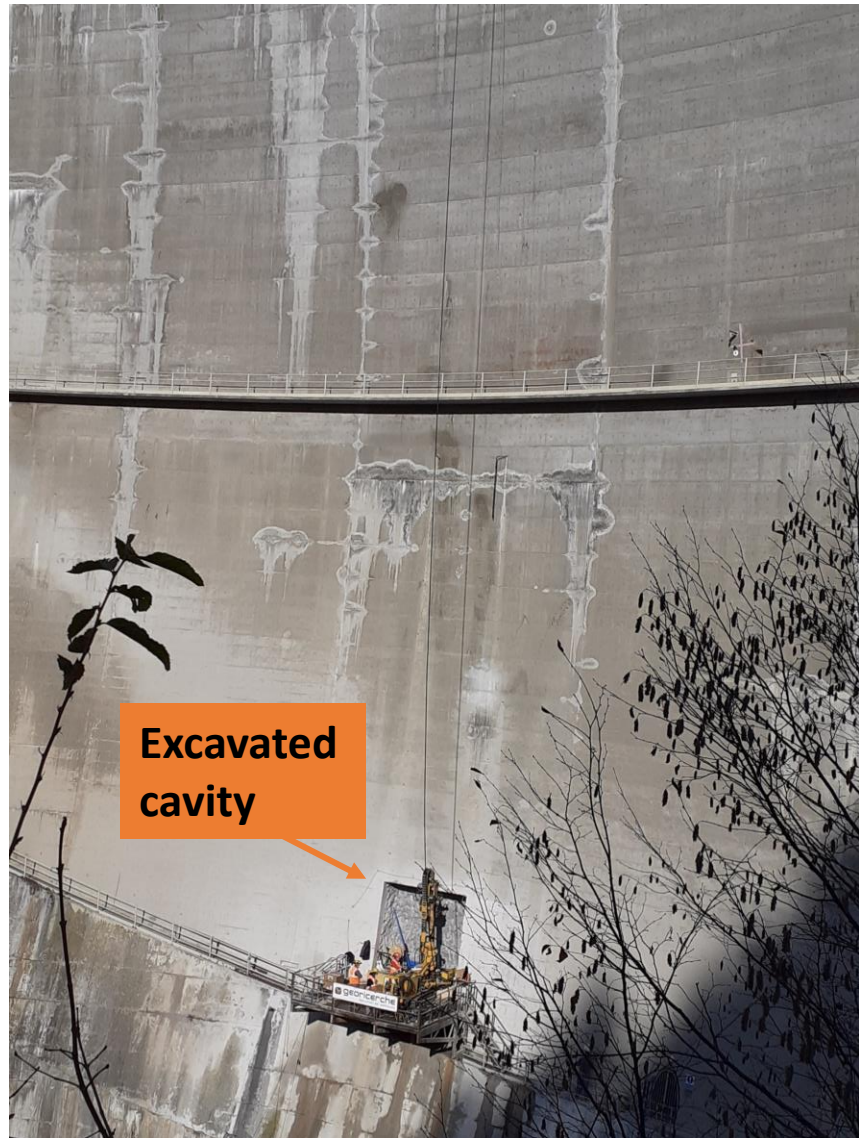
Traditional monitoring system: displacements

Extensometer lengths:

- 3.2m
- 16.25m
- 40.5m
- 59m
- 85.5m

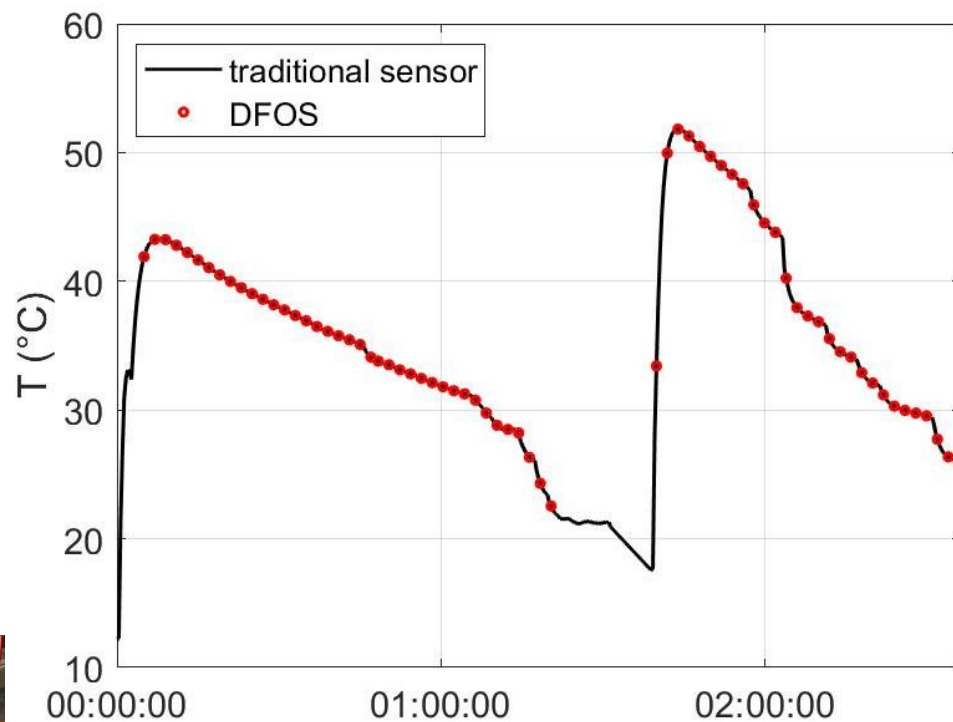
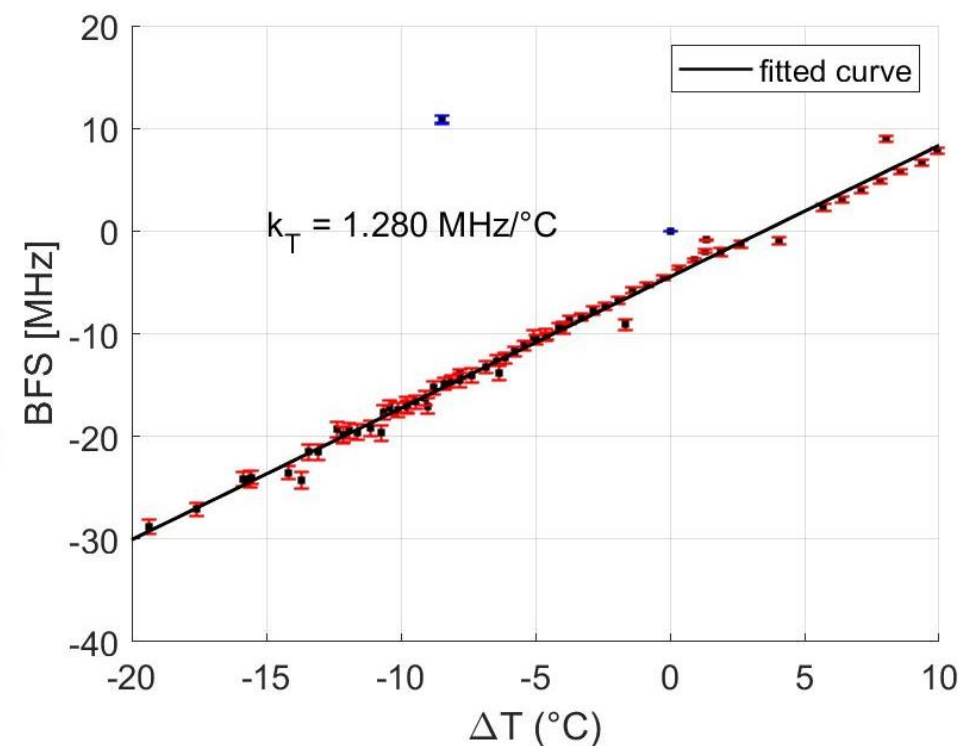
Distributed Optical Fiber Sensors: calibration

Calibrated thermal coefficient of DFOS: $k_T = 1.280 \text{ MHz}/^{\circ}\text{C}$

Calibrated optical strain correction due to temperature variation

$1^{\circ}\text{C} = 23 \mu\epsilon$ (against $1^{\circ}\text{C} = 44 \mu\epsilon$ declared by the producer)

- The strain measured by DFOS at the crest, in the range 200-300 $\mu\epsilon$, are in good agree with the topographic survey, even with small overestimation on the lateral sectors
- DFOSs detect the irregular response of the joints in the crest
- In the foundation about 50-100 $\mu\epsilon$, but larger than those measured with the extensometers (10-30 $\mu\epsilon$)
- Due the very small strain developed by the dam it is crucial to carry out the calibration

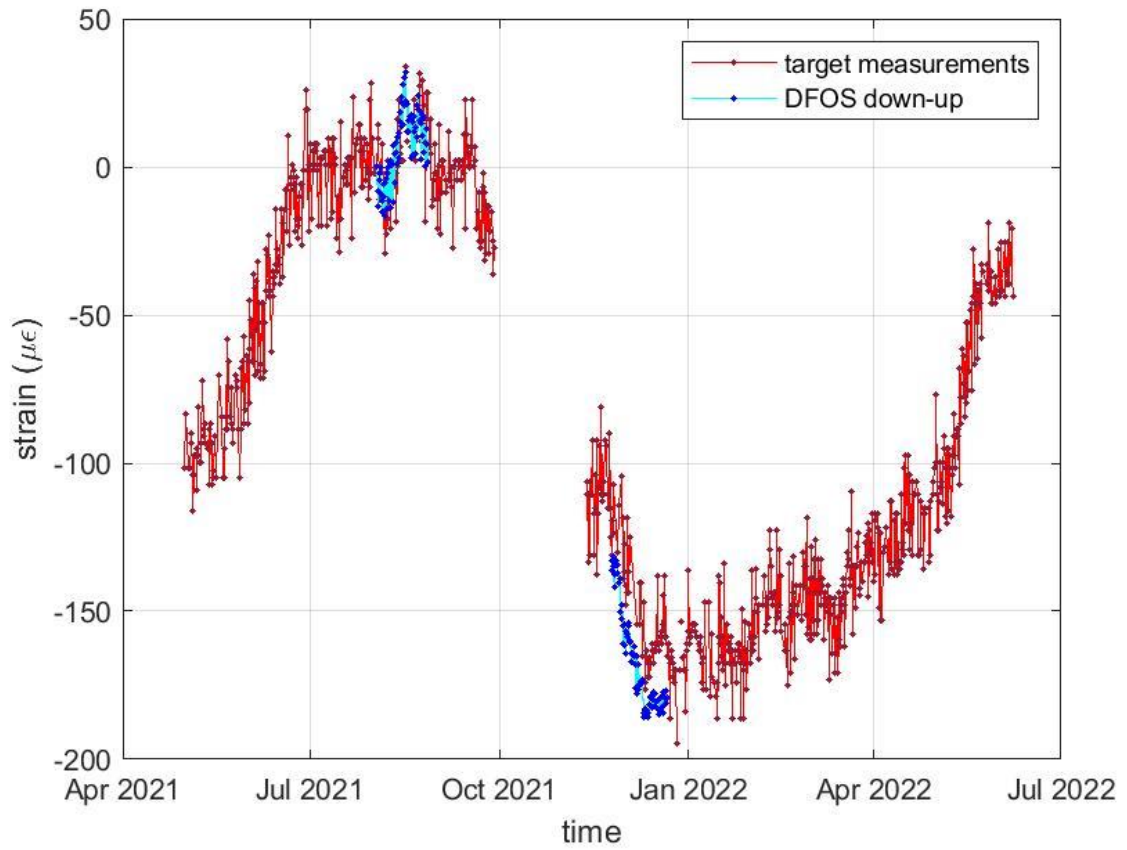
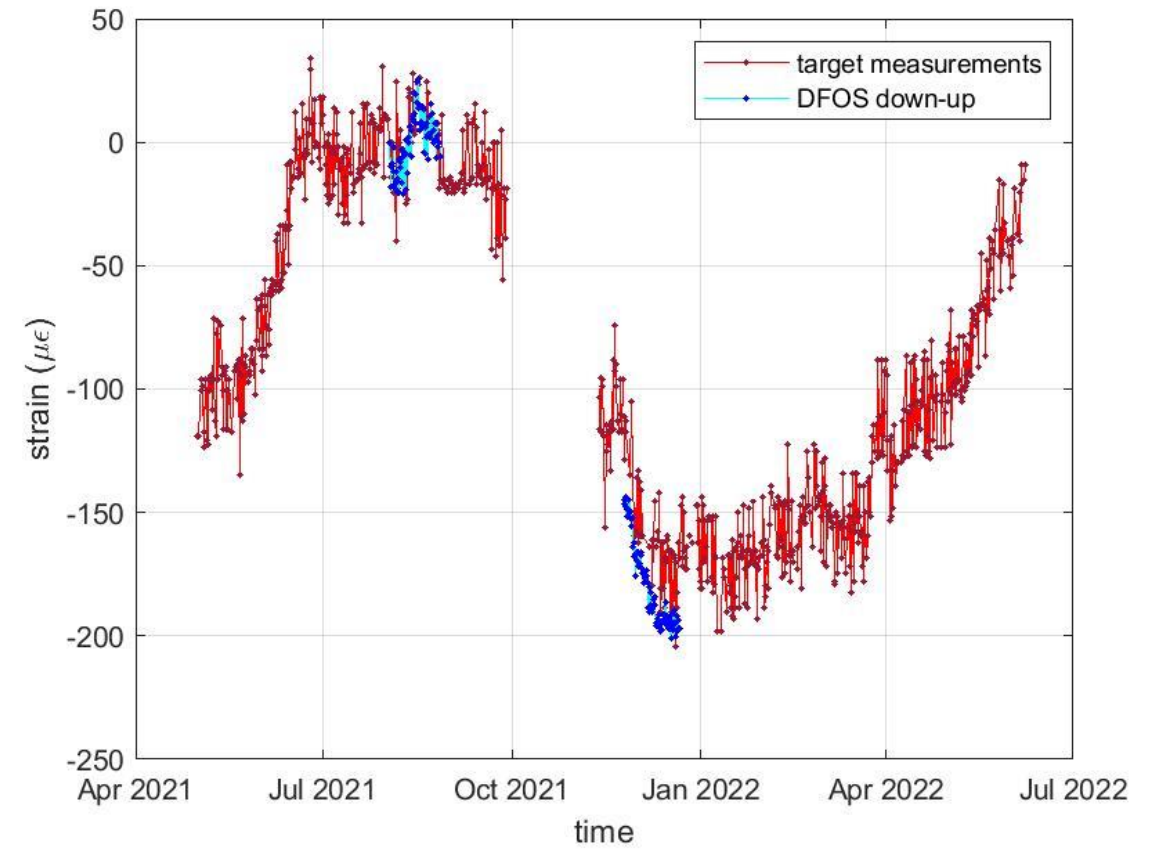
Strain by DFOS at the crest – continuous measure

Comparison DFOS and topographic measures for the two central sectors

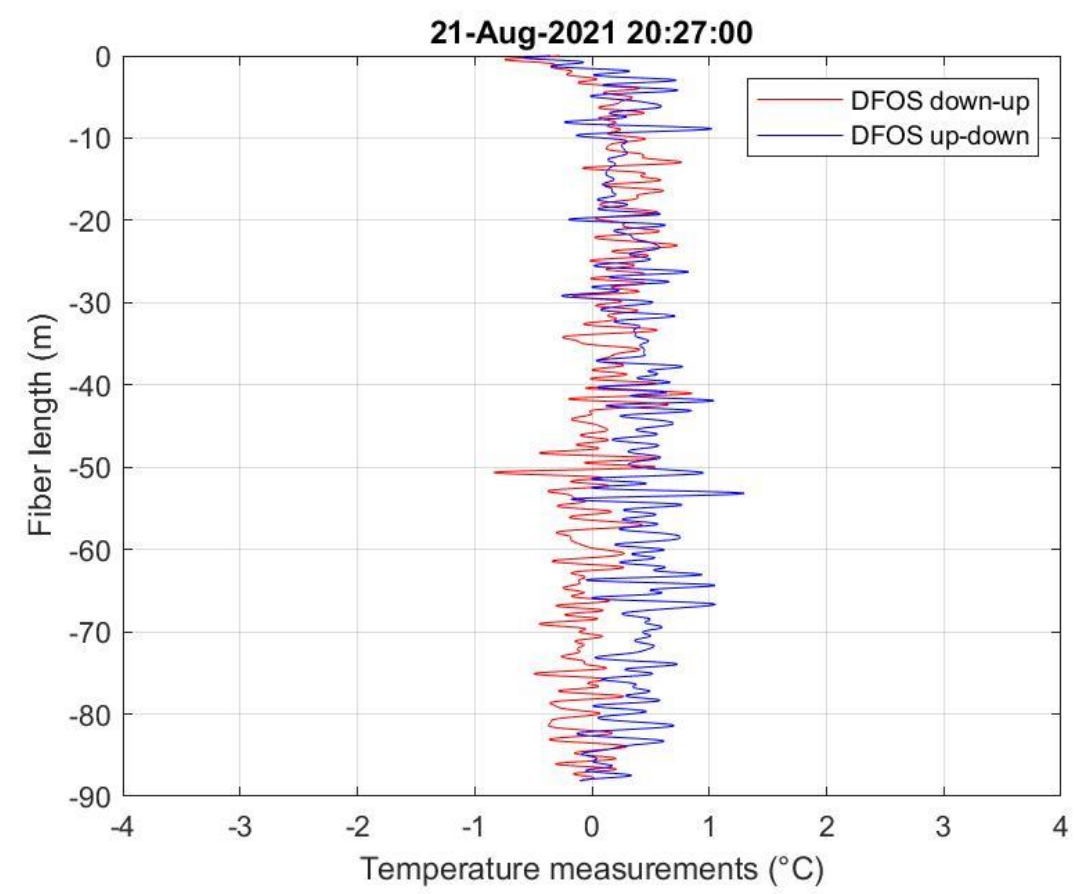
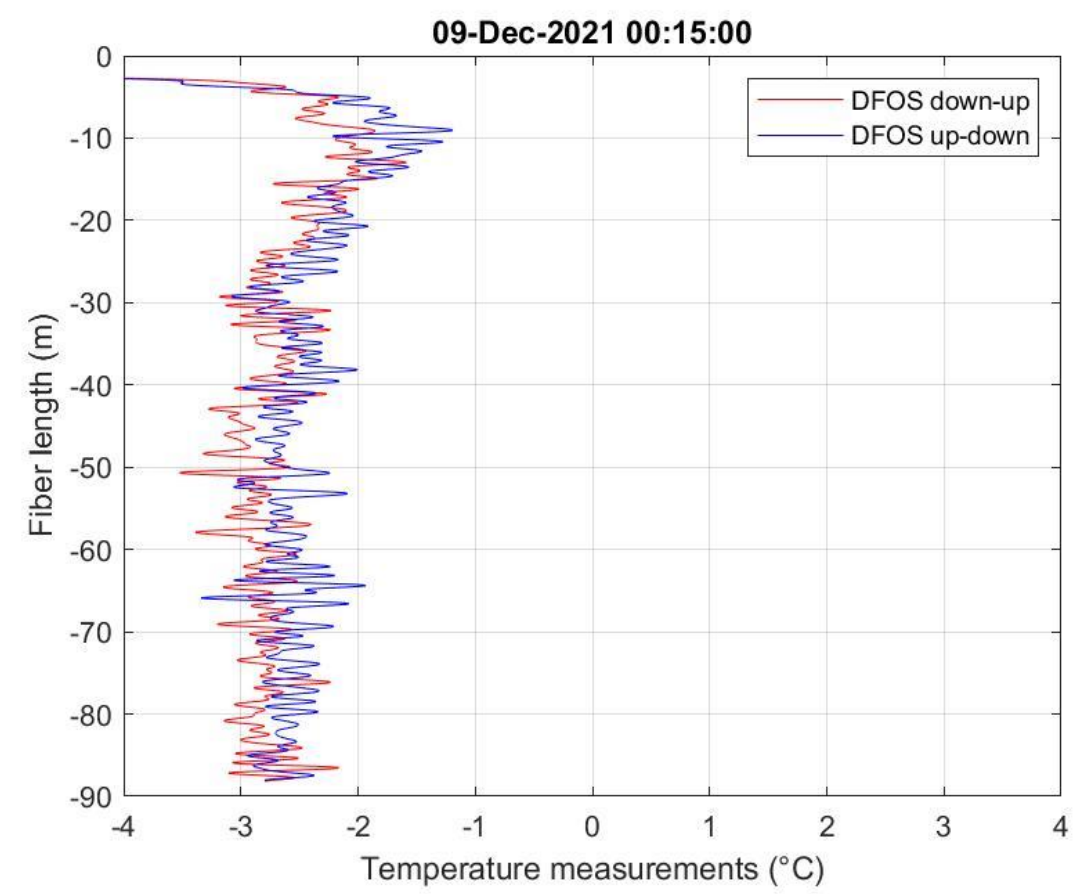
Temperature by DFOS in the foundation – single measure

Reference measure: at 12.00 of 2 August 2021

- After calibration, DFOS obtain measures congruent with those of traditional sensors, both in foundation and at the crest
- At the crest the temperature excursions are above 20°C
- In the foundation the annual variation of temperature is less (4°C), even if the thermal response changes according to the depth
